AC NO: 20-78

MAINTENANCE INSPECTION NOTES FOR McDONNELL DOUGLAS DC-8 SERIES AIRCRAFT

SUBJECT: MAINTENANCE INSPECTION NOTES FOR McDONNELL DOUGLAS DC-8
SERIES AIRCRAFT

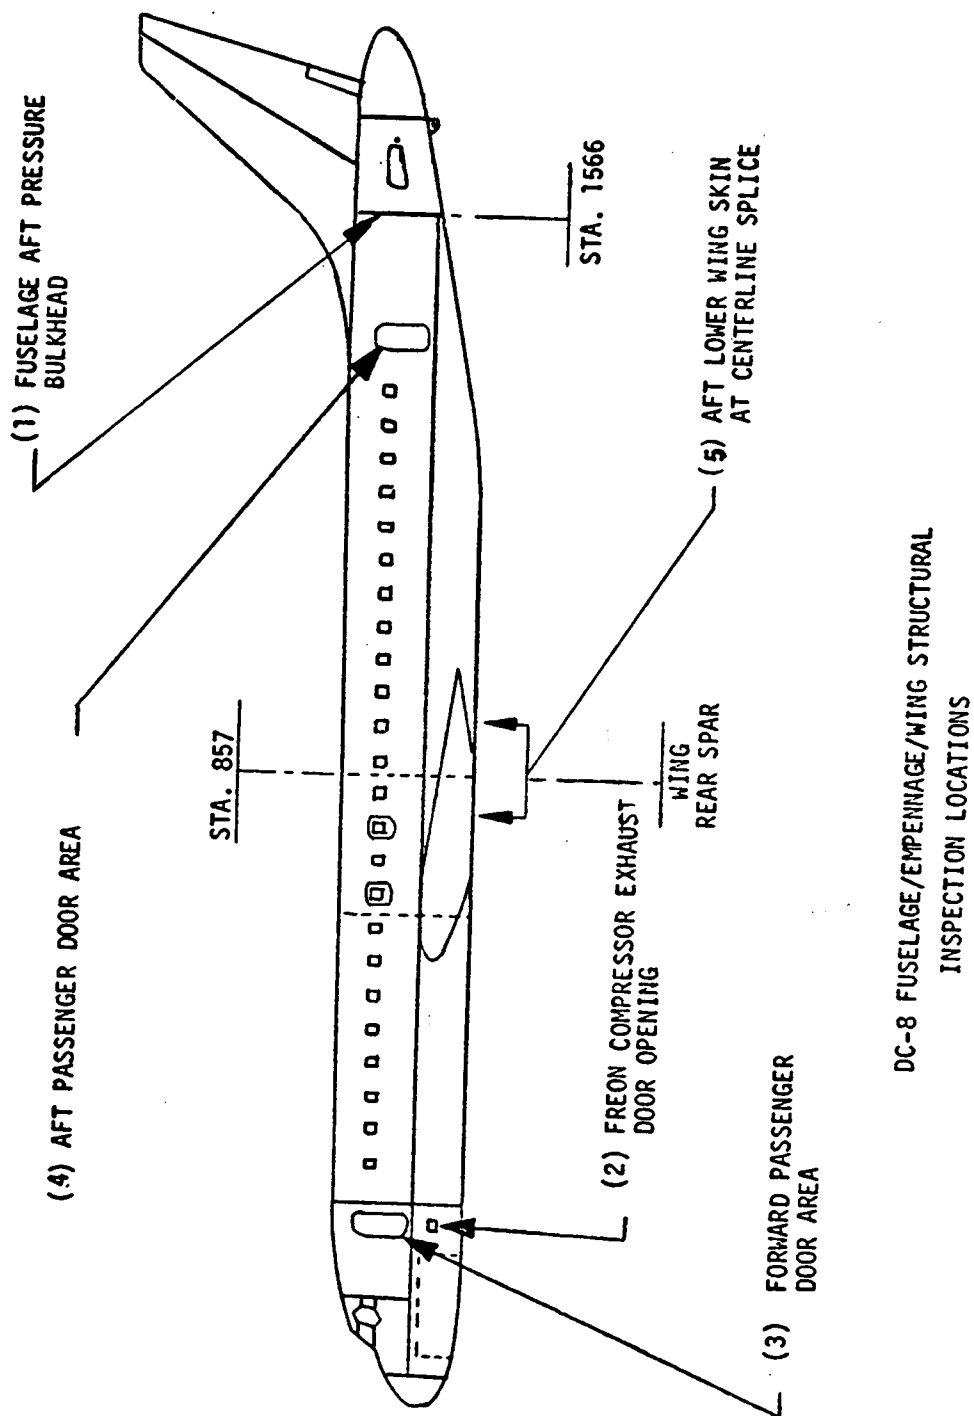
Fig. 7 DC-8 Structural Inspection Locations

1. DESCRIPTION. Five significant structural items are discussed in this appendix. If in a high time DC-8 aircraft a crack occurs in one of these items and is allowed to exist for an extended period of time, the continued airworthiness of the aircraft may be adversely affected. In Figure 7, the general location of these items are described.

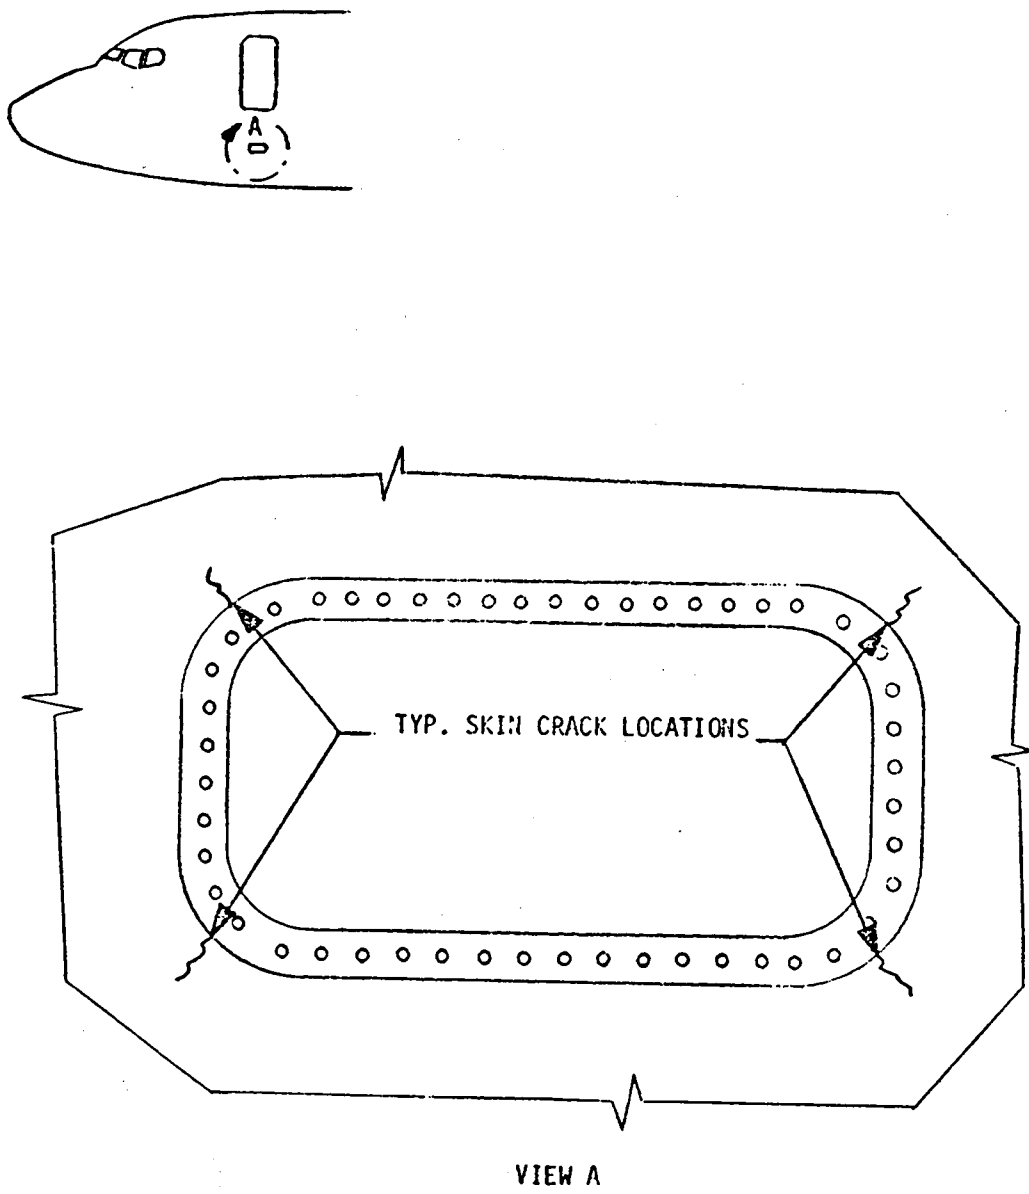
Fig. 9 Freon Compressor Exhaust Door Opening

- (1) Location. Below forward passenger door at longeron 29 (See Figure 9, Appendix 3).
- (2) Applicable Airworthiness Directive. None
- (3) Other Reference Data. None
- (4) Probable Consequences. Extensive cracking around the freon compressor exhaust door opening may lead to more serious structural damage.
- (5) Recommendations. Periodically inspect to assure continued structural integrity.

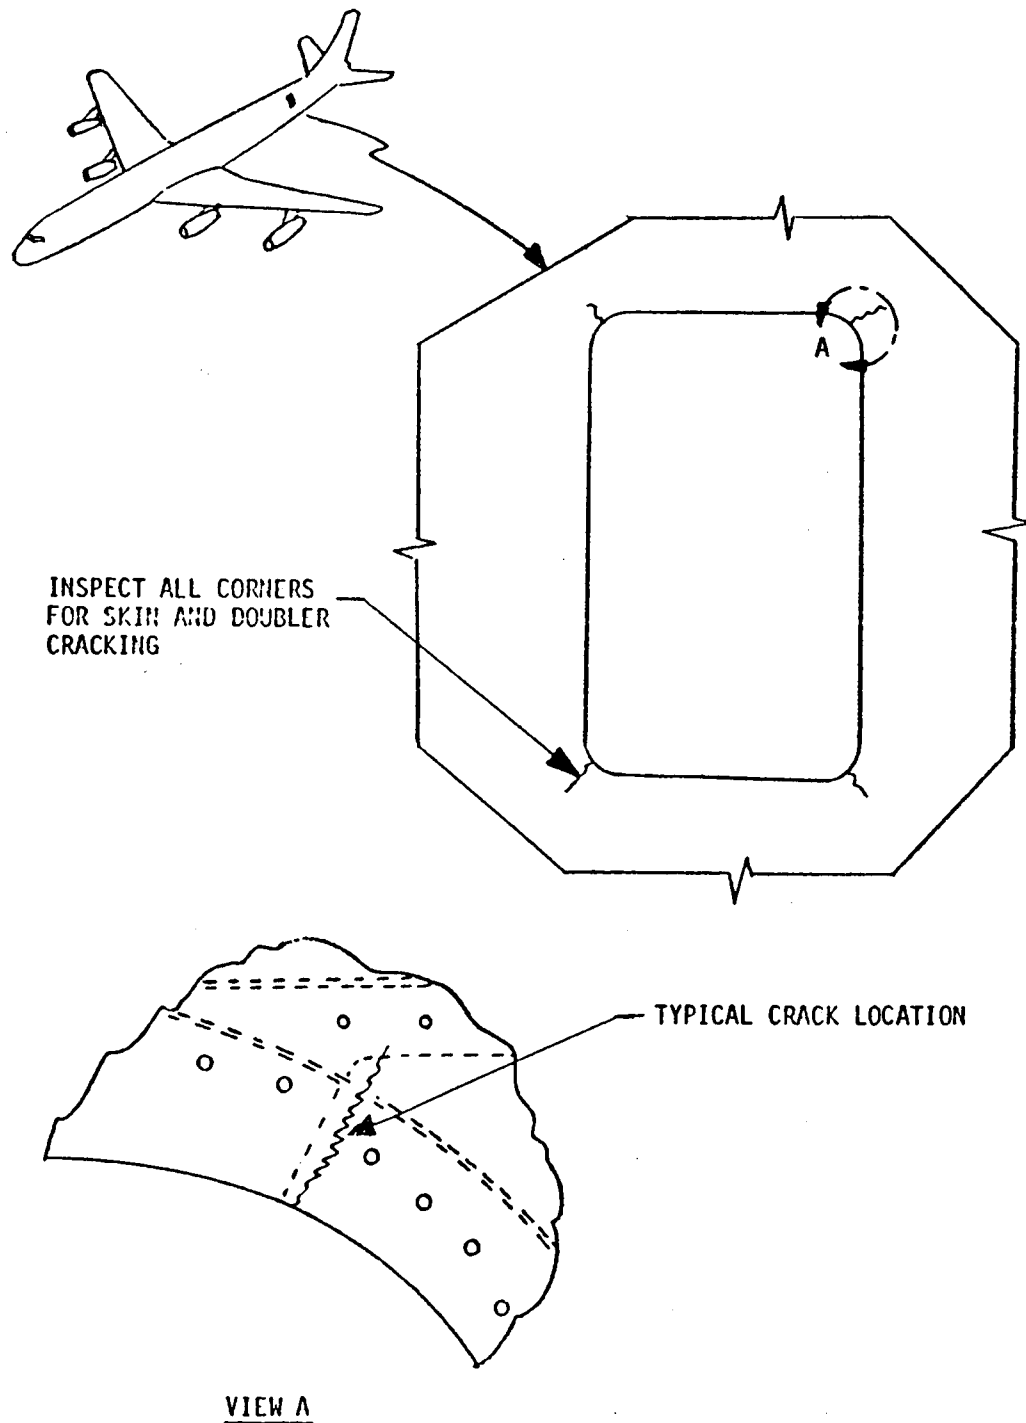
Fig. 11 Aft Passenger Door Area

- (1) Location. Aft fuselage, left hand side (see Figure 11, Appendix 3)
- (2) Applicable Airworthiness Directive. None
- (3) Other Reference Data. None
- (4) Probable Consequence. Extensive fuselage cracks in this may lead to more serious damage.
- (5) Recommendation. Periodically inspect fuselage skin around door cutout to assure continued structural integrity.
